HOUSATONIC RIVER BASIN
ANSONIA, CONNECTICUT
QUILLINAN RESERVOIR DAM
CT 00024

PHASE I INSPECTION REPORT
NATIONAL DAM INSPECTION PROGRAM

February 1980

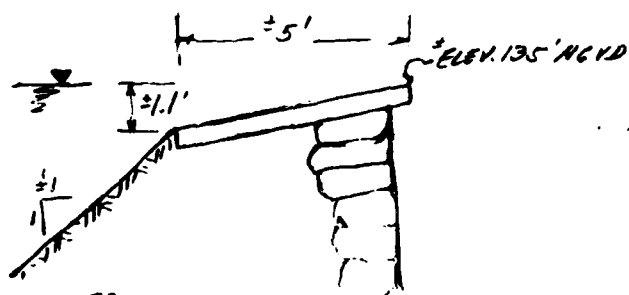
SPILLWAY
CROSS-SECTION

$\frac{1}{2}$ EDGE (\pm) ELEV. $\pm 135'$ NGVD). THE $\frac{1}{2}$ FACE SLOPES AT (\pm) $1''$ TO $1''$ (\pm) $1.35''$ TO $1''$ ON THE ORIGINAL DWG. - 1884). IN PLAN, THE SPILLWAY LENGTH IS (\pm) $35'$. THE HEIGHT BETWEEN THE SPILLWAY CREST AND THE TOP OF THE MASONRY DAM IS (\pm) $H \approx 3.5'$.

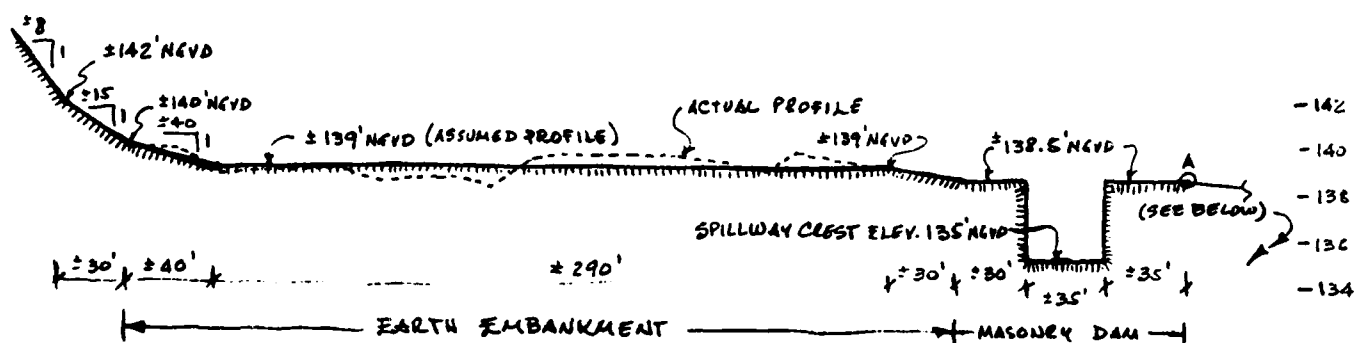
QUILLINAN RESERVOIR - OVERFLOW PROFILE -

THE TOP ELEVATION OF THE LEFT EMBANKMENT VARIES FROM $(\pm) 138'$ NGVD TO $(\pm) 140'$ NGVD AND PRESENTS WITHIN THESE LIMITS A VERY IRREGULAR OVERFLOW PROFILE (SEE SKETCH BELOW). THE RIGHT EMBANKMENT FALLS TO (\pm) ELEV. $138'$ NGVD ($(\pm) 0.5'$ LOWER THAN THE TOP OF THE MASONRY DAM), AND TIES WITH THE PARKING AREA OF THE ANSONIA-DERBY WATER CO. BUILDING TO FORM THE OVERFLOW SECTION. IT WILL BE ASSUMED THAT THIS BUILDING (FF ELEV. $(\pm) 139.8'$ NGVD) CLOSES VERTICALLY, ABOVE GROUND ELEV. $(\pm) 138.5'$ NGVD AT THE RIGHT SIDE OF THE OVERFLOW SECTION. TO THE LEFT, THE DAM AND ADJACENT TERRAIN RAISE GRADUALLY AS SHOWN BELOW ON THE OVERFLOW PROFILE ASSUMED FOR THIS COMPUTATION.
